Storm Drain Modeling Data & CCTV Storm  
Drain Condition Assessment Memorandum

**Date:** July 7, 2020  
**From:** Joey Hegna, P.E. – CRW Engineering Group, LLC  
**Project:** Lois Drive and 32nd Avenue Pathway – Benson Boulevard to Minnesota Drive  
**Project No:** PM&E# 19-08 (CRW# 10145.00)  
**Subject:** Storm Drain Condition Assessment (DRAFT)

Lois Drive and 32nd Avenue Pathway – Benson Boulevard to Minnesota Drive  
Storm Drain Condition Assessment (DRAFT)

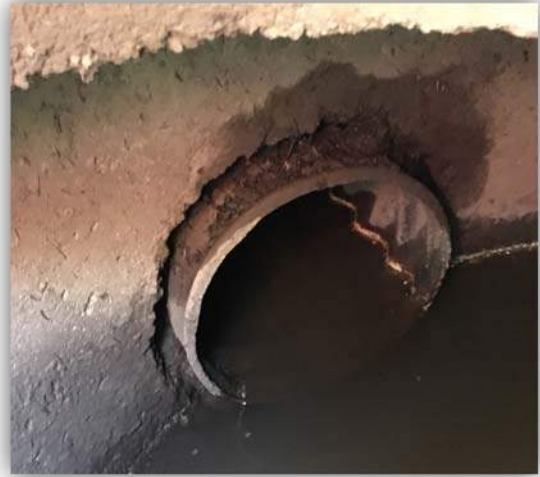
*Photo 3 - Grout Loss at Pipe Penetration*

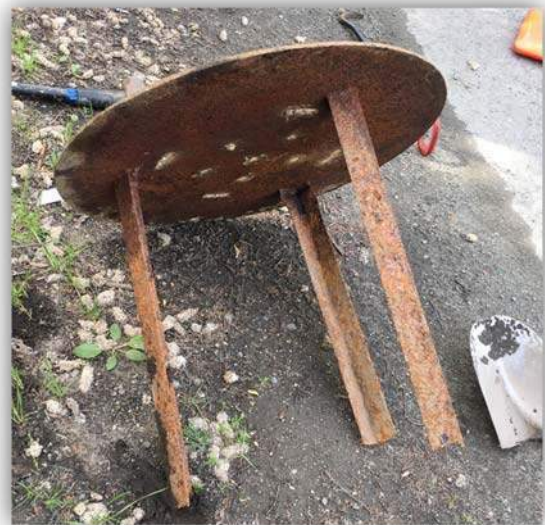
*Photo 4 - Non-standard Manhole Lid*
