# Appendix C

Storm Drain CCTV Inspection Forms

## Lois Drive and 32nd Avenue Pathway MOA Pipe #28932 - W. 32nd Ave (west of Minnesota Dr)

## Storm Drain Structure Inspection Forms

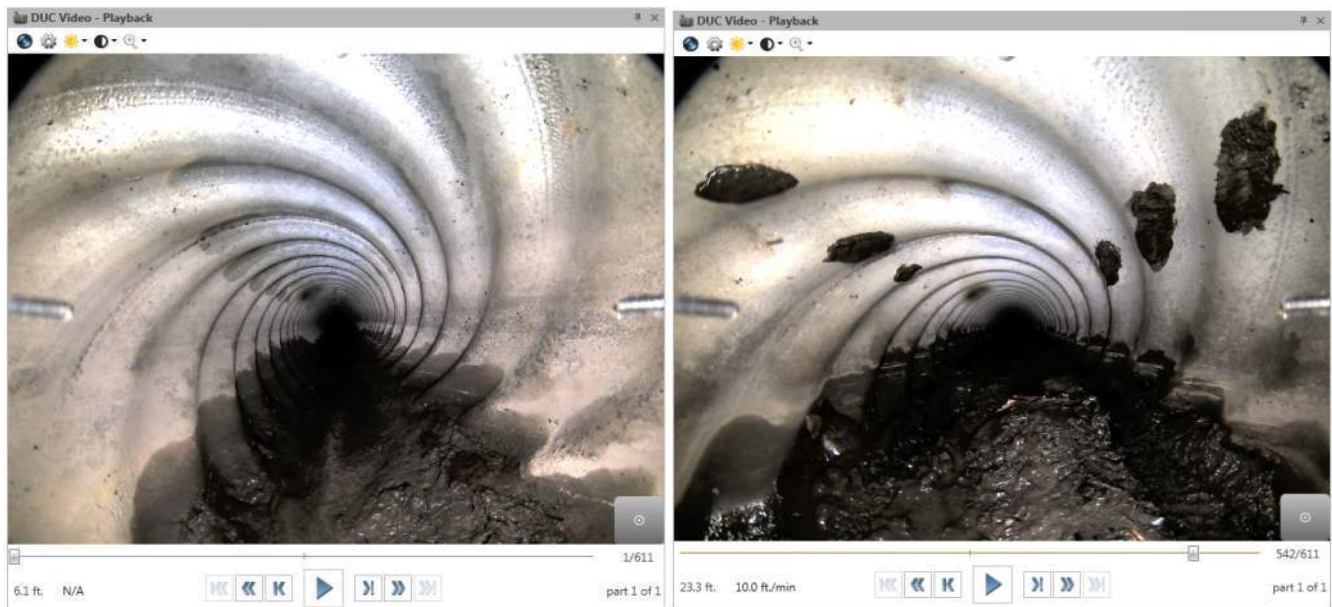
Debris/Obstructions: CCTV abandoned at 24.1 feet due to significant debris in invert, minor to moderate debris from 6.3 feet to 19.7 feet.

Miscellaneous/Defect Notes: Pipe appears to be in good condition, but leaf buildup is restricting flow. Looks like some root intrusion is possible along walls.

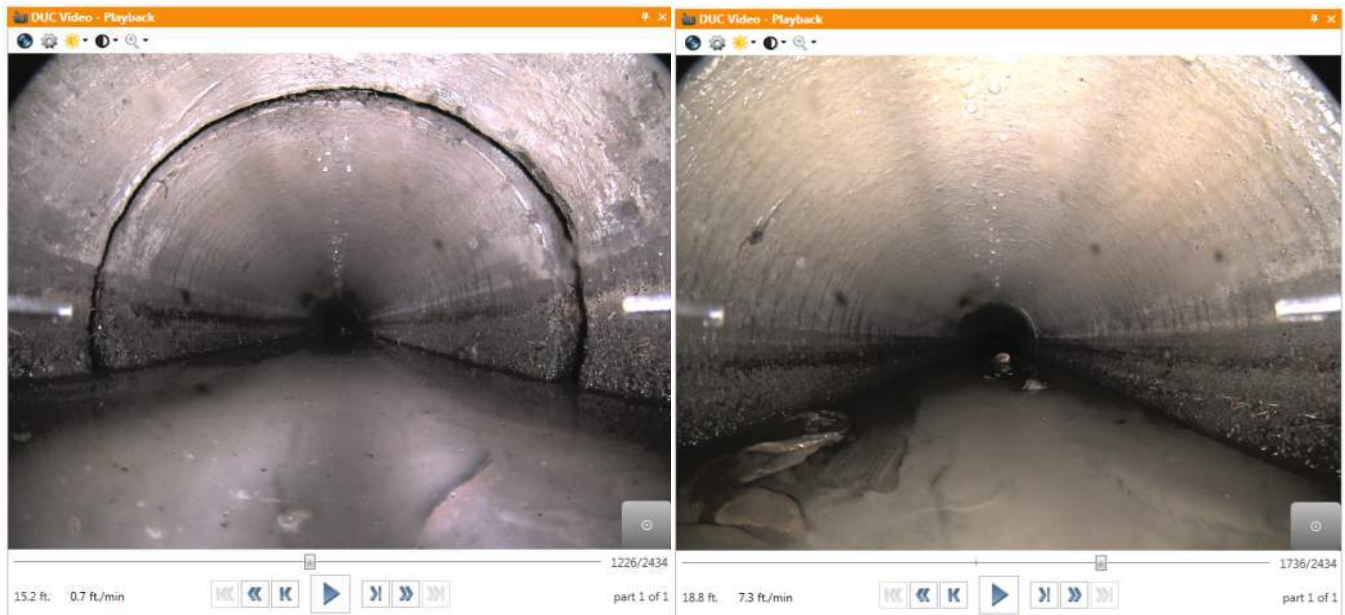
Debris/Obstructions: CCTV abandoned at 23.6 feet due to significant debris in invert.

Miscellaneous/Defect Notes: Offset joints at 15.5 feet & 21.8 feet. Pipe exceeds 300 foot max. manhole spacing per MASS.

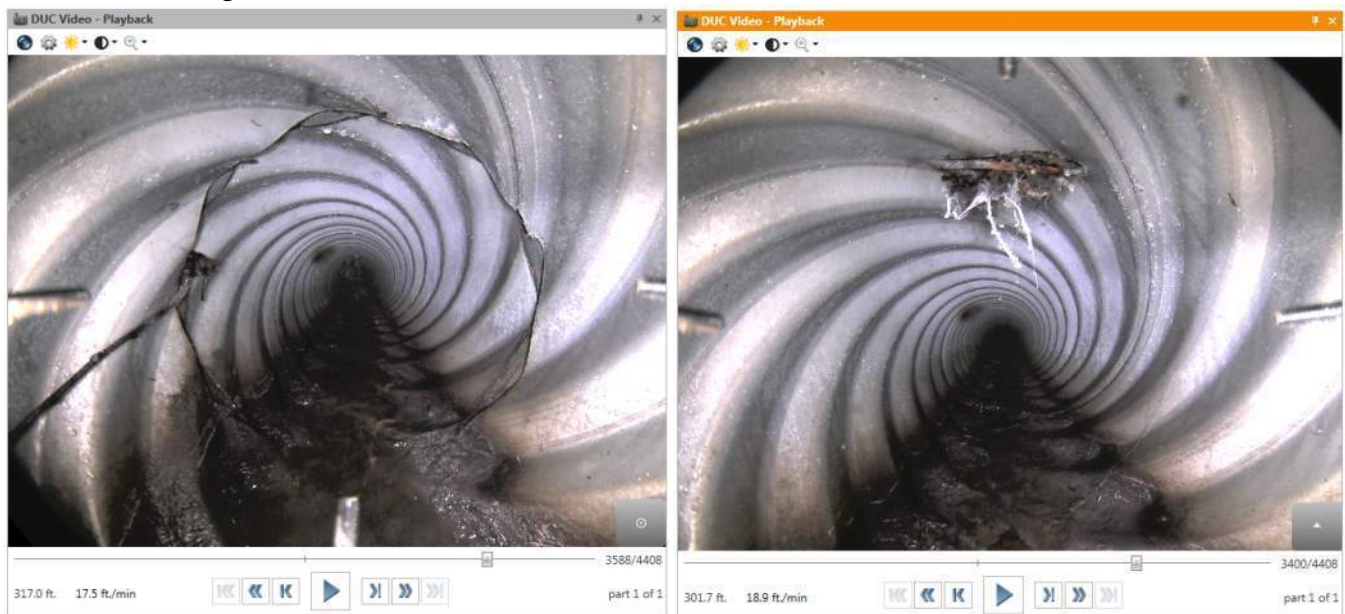
Debris/Obstructions: Minor to moderate debris present throughout length of pipe.

Miscellaneous/Defect Notes: Mineralization/infiltration at pipe joints at 132.1 feet, 197.3 feet & 216.6 feet. Root intrusion at pipe joints at 216.6 feet & 317.0 feet. 1"x4" gouge through pipe at 12 o'clock position at 301.7 feet, soil visible.

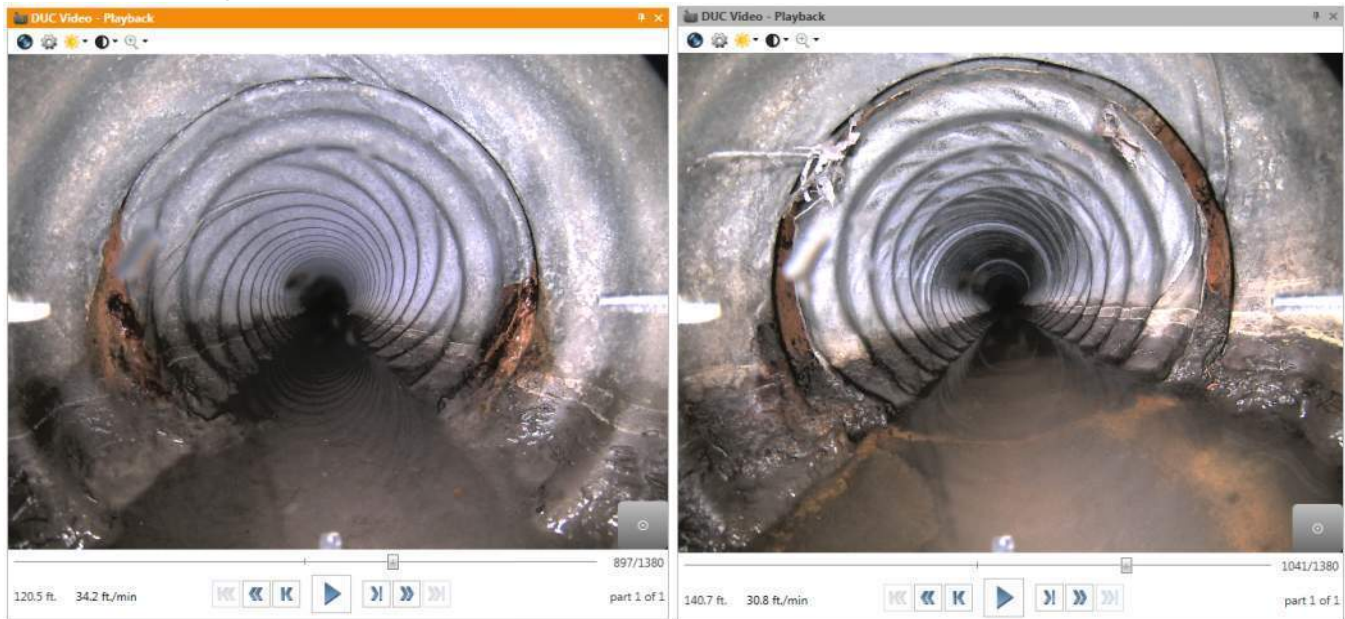
Debris/Obstructions: Minor to moderate debris present throughout length of pipe.

Miscellaneous/Defect Notes: Mineralization/infiltration at pipe joints at 39.6 feet, 59.9 feet, 120.6 feet & 161.0 feet. Significant joint separation at 140.7 feet.

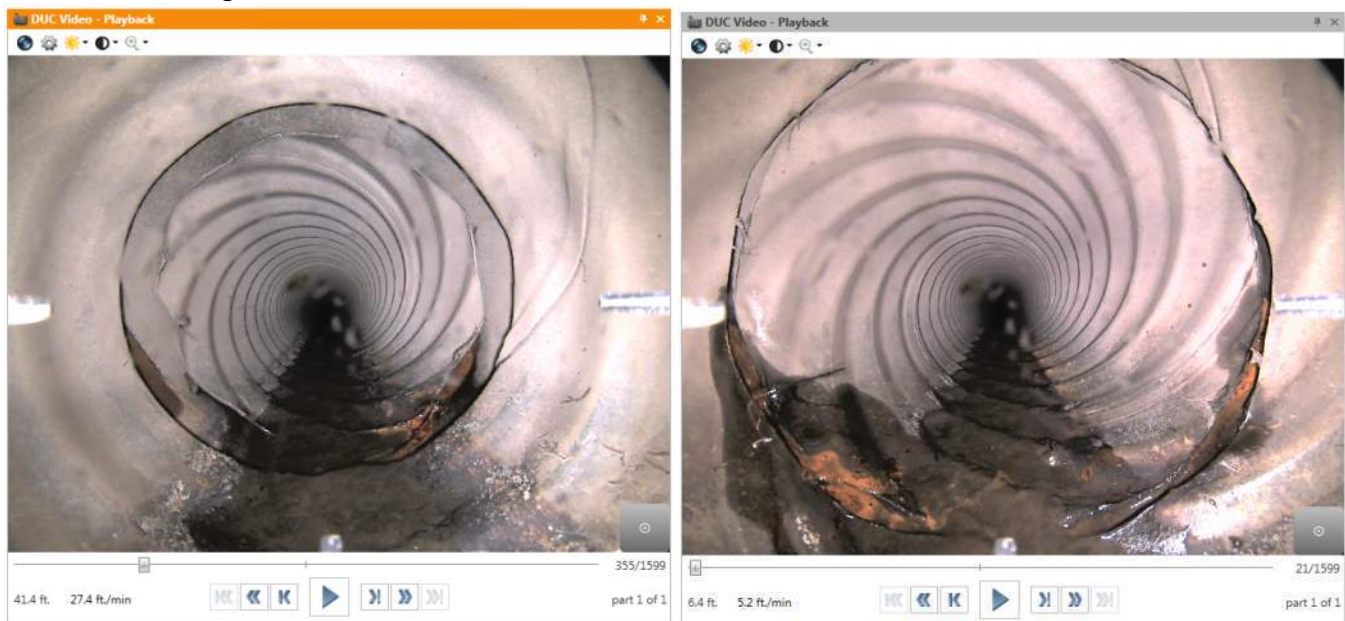
Diameter/Material: 15" CMP  
Install Year: 1982  
Flow Depth: < 10% of full pipe flow  
Debris/Obstructions: Minor debris present throughout length of pipe.  
Miscellaneous/Defect Notes: Minor metal loss/corrosion present throughout length of pipe.  
Offset joint at 152.1 feet. Mineralization/Infiltration at pipe joint at 6.4 feet, 21.5 feet, 72.3 feet and 121.8 feet. Joint separation at 41.7 feet.

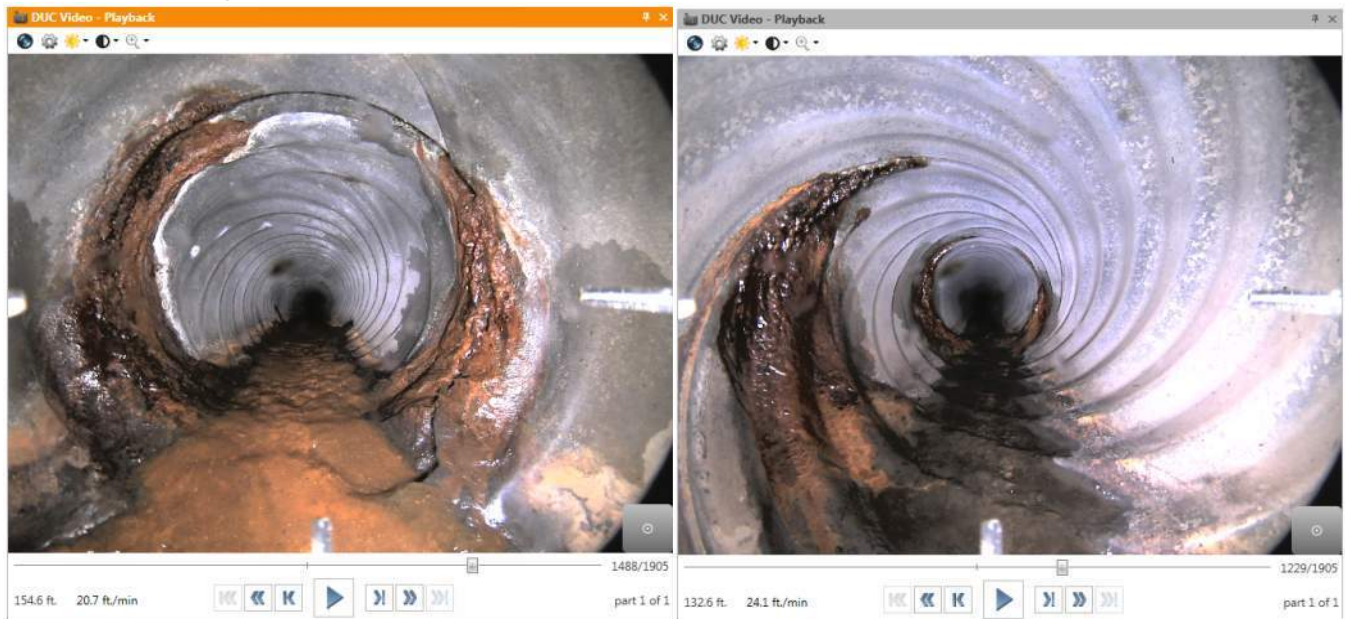
Diameter/Material: 15" CMP  
Install Year: 1982  
Flow Depth: < 10% of full pipe flow  
Debris/Obstructions: Minor debris present from 0 feet to 143.1 feet. Moderate to significant mineralization present from 143.1 feet to end of pipe.

Miscellaneous/Defect Notes: Minor metal loss/corrosion present from 0 feet to 143.1 feet. Moderate to significant metal loss/corrosion present from 143.1 feet to end of pipe. Mineralization/infiltration near flow line at 4 o'clock position at 131.1 feet. Mineralization/infiltration near along CMP seam at 9 o'clock position at 132.6 feet. Significant mineralization/infiltration at pipe joints at 114.2 feet, 134.3 feet & 154.9 feet. Surface damage/corrosion at 10 o'clock & 2 o'clock at 55.0 feet.

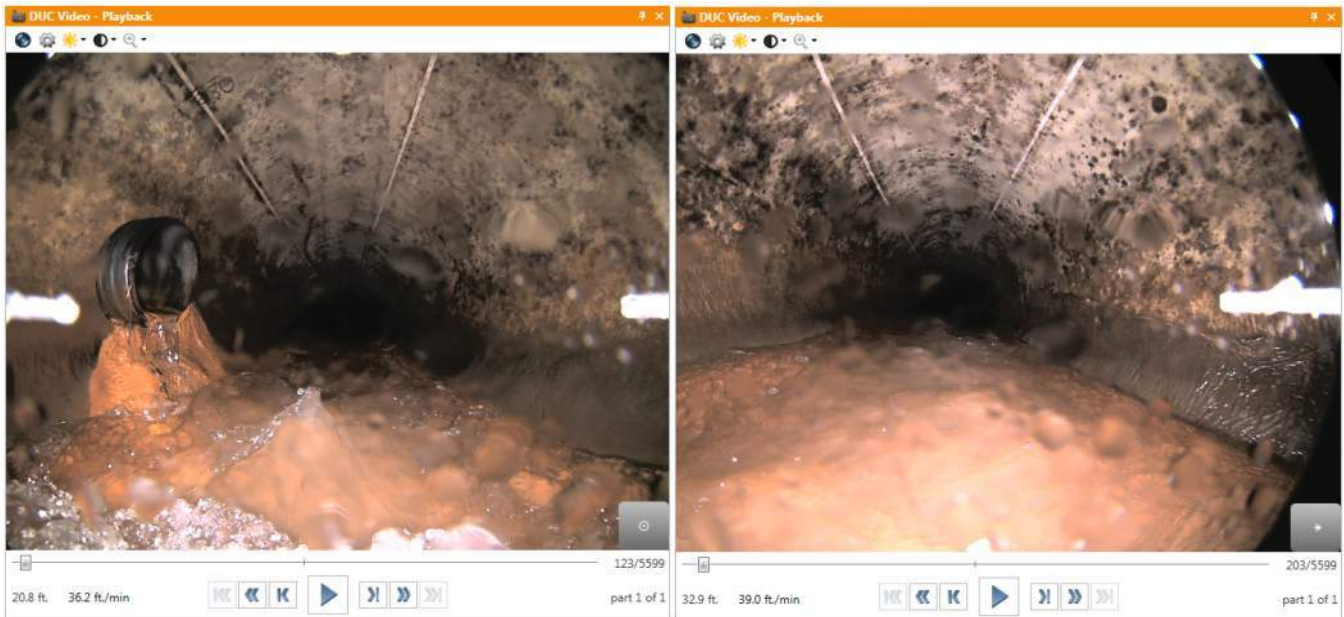
Diameter/Material: 48" CMP/Lined  
Install Year: Unknown  
Flow Depth: < 25% of full pipe flow  
Debris/Obstructions: Moderate mineralization present throughout length of pipe.  
Significant debris/blockage at 260.5 feet.

Miscellaneous/Defect Notes: According to CCTV operator, this pipe was previously lined with CIPP. Operator noted lining failures at 32.9 feet, 60.3 feet, 131.6 feet & 182.1 feet. CPEP lateral at 9 o'clock position at 21.3 feet with significant mineralization at discharge point. CMP lateral at 11 o'clock position at 133.2 feet with moderate mineralization at discharge point.

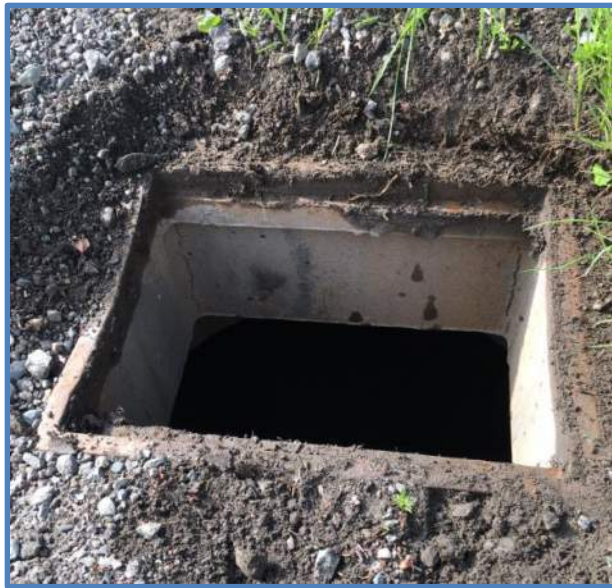
Photo 3 - Frame & Reducing Slab

- Grout spalling at pipe penetration
- Non-standard inlet, 11.5" x 15", rectangular, frame depth 10"
- No grade rings, frame placed on reducing slab

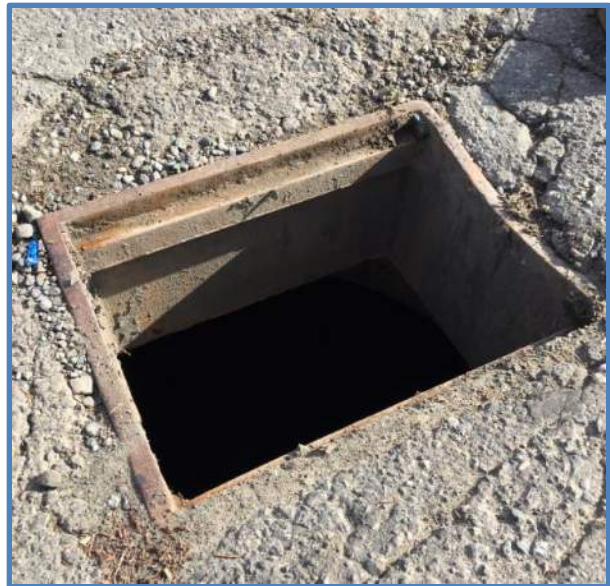
Photo 4 - Frame & Reducing Slab

- Non-standard inlet, 11.5" x 15", rectangular, frame depth 10"
- No grade rings, frame placed on reducing slab
- Grout spalling around pipe penetration
- Metal loss at invert of pipe

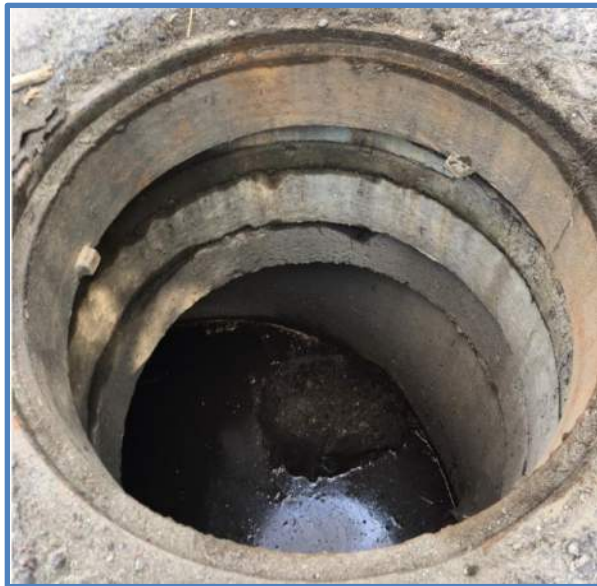
Photo 3 - Frame, Grade Rings & Reducing Slab

- Flat intake lid
- Minor vertical cracking in 6" grade ring
- Minor grout spalling in pipe penetration
- Significant debris in sump

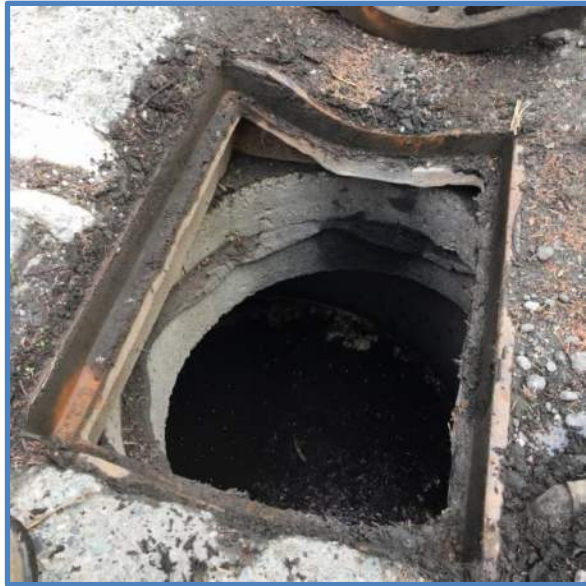
Photo 3 - Frame, Grade Rings & Reducing Slab

- Type 2 curb inlet, 24" x 18"
- Curb inlet is at skewed angle from curb line
- Grade ring placement is offset from frame and reducing slab
- Crack in grout above pipe penetration

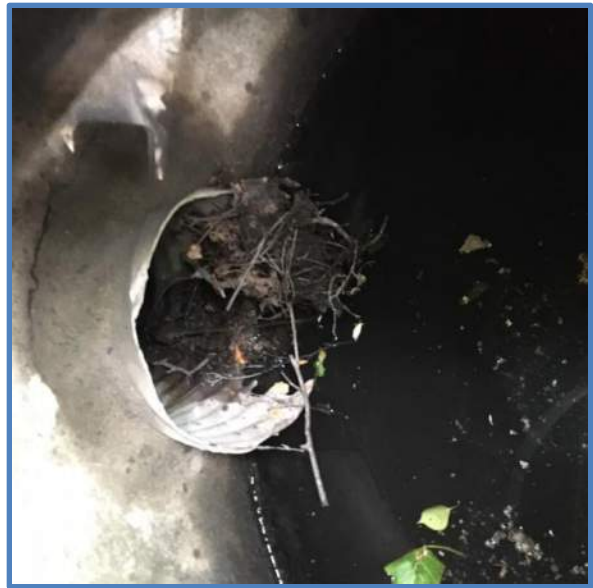
Photo 4 - Outlet Pipe Penetration

- Type 2 curb inlet, 24" x 18"
- Significant metal loss in west pipe's invert
- Debris in west pipe's invert

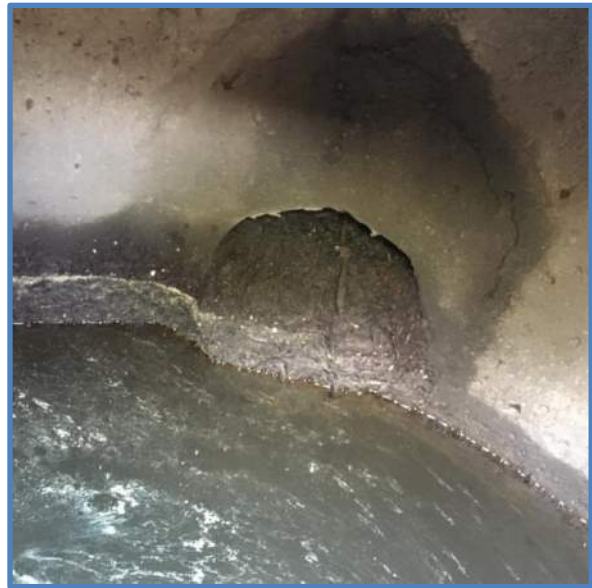
Photo 4 - Inlet Pipe & Pipe Penetration

- Flat intake cover, 25" diameter
- Non-standard frame height 3"
- Minor offset between barrel & reducing slab
- Metal loss in west 10" CMP pipe invert
- East pipe full of debris
- Sump is full of debris

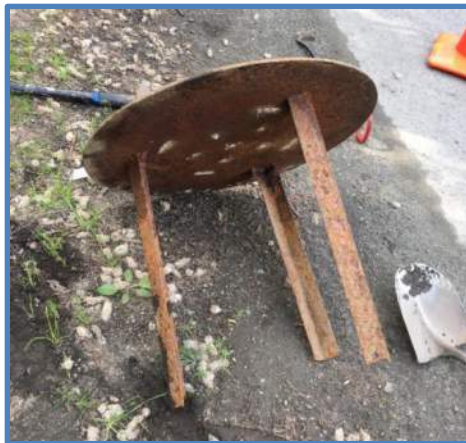
Photo 3 - Manhole Lid

- Non-standard lid with 3 angle pieces welded onto lid
- 12 non-standard steel ladder rungs

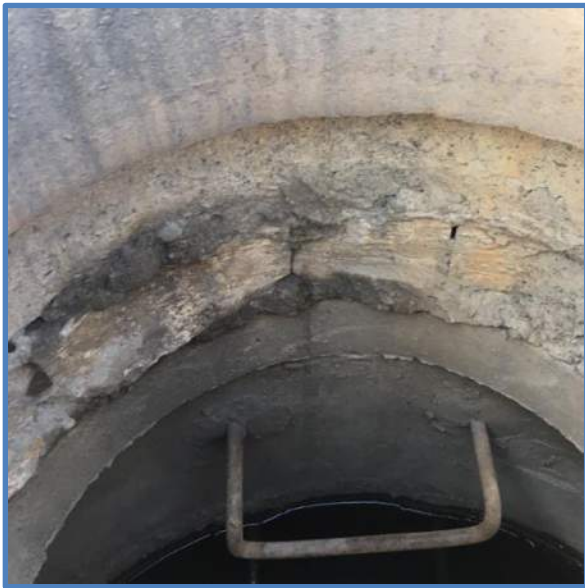
- 1 layer of non-standard grade ring is composed of bricks (in poor condition)
- No cone, grade rings on reducing slab
- 2 visible non-standard steel ladder rungs, 17" apart
- Non-standard frame with 10" height
- Non-standard lid
- Some sediment buildup in pipes
- Grout cracking at west pipe penetration
- NW pipe (8" plastic) was not shown in MOA record drawings and MOA drainage arcgis map

Photo 3 – Frame, Brick Grade Ring, Reducing Slab, and Ladder Rung

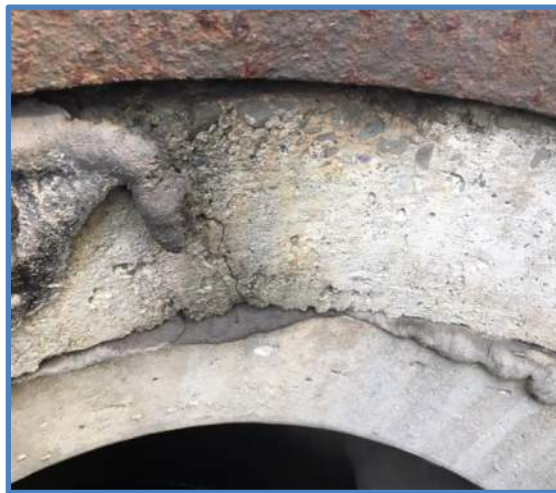
- 4 non-standard steel ladder rungs
- Buried MH cover in gravel
- Vertical cracking in grade ring
- Grade ring placement is offset from cone and frame

Photo 3 - Cracking in Grade Ring
