# Appendix C

Storm Drain CCTV Inspection Forms

## Lois Drive and 32nd Avenue Pathway MOA Pipe #28932 - W. 32nd Ave (west of Minnesota Dr)

## Storm Drain Structure Inspection Forms

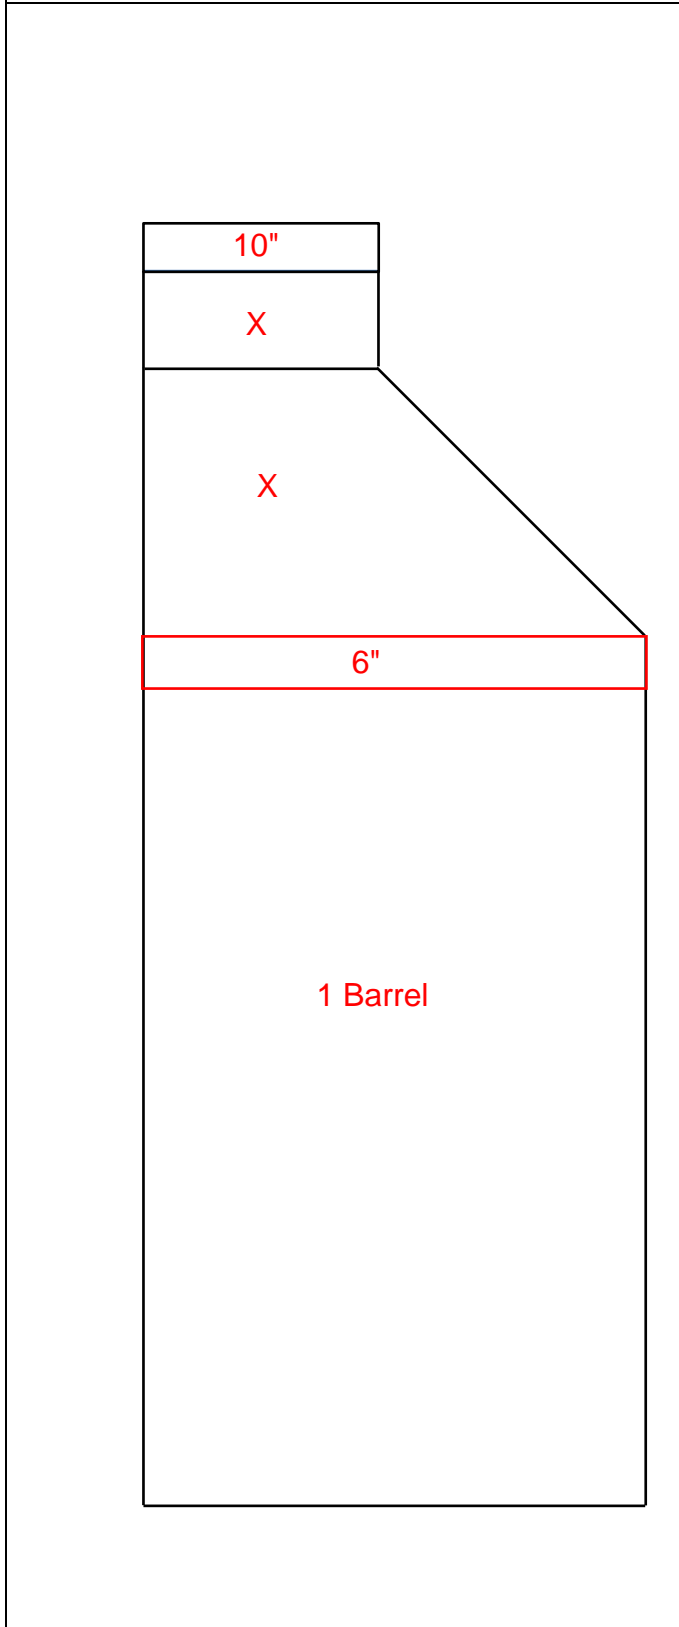
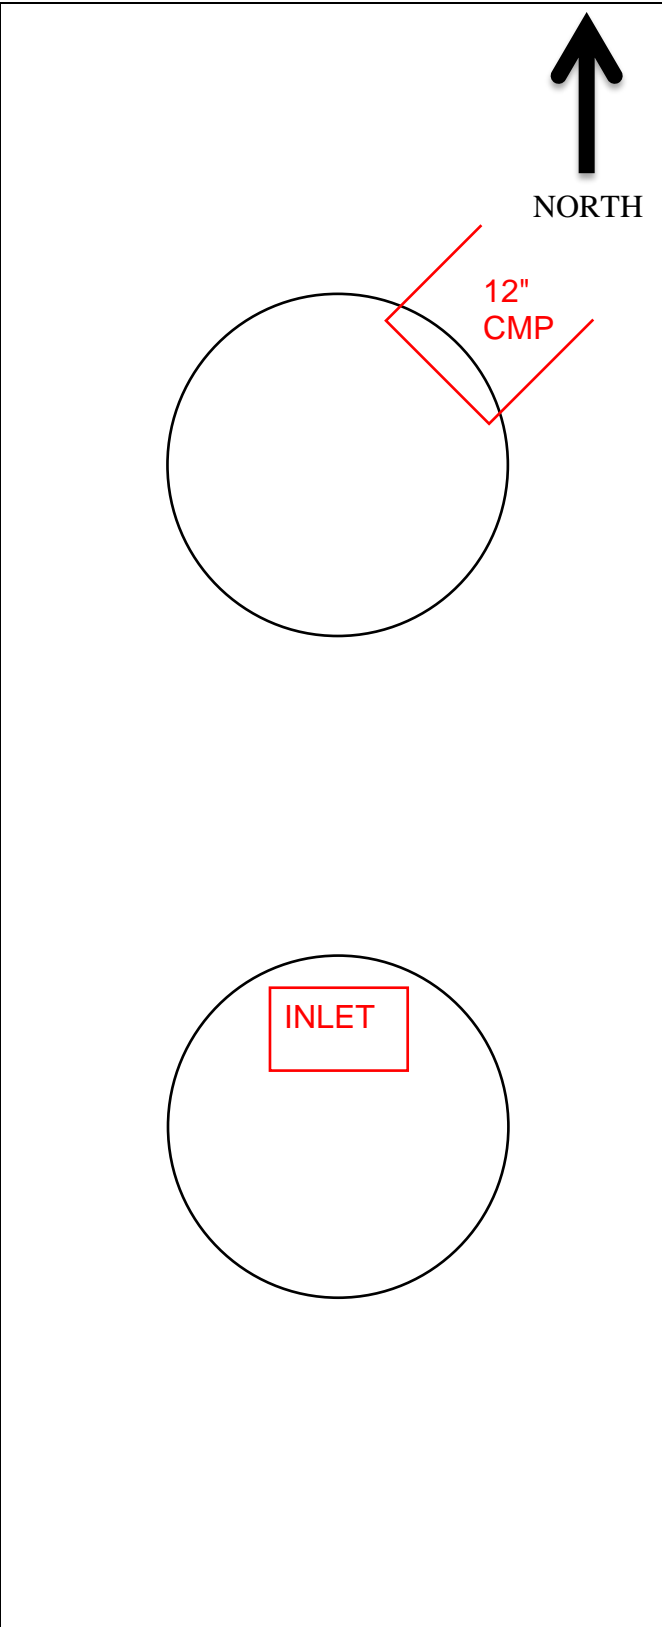
MANHOLE SKETCH

- Grout spalling at pipe penetration
- Non-standard inlet, 11.5" x 15", rectangular, frame depth 10"
- No grade rings, frame placed on reducing slab

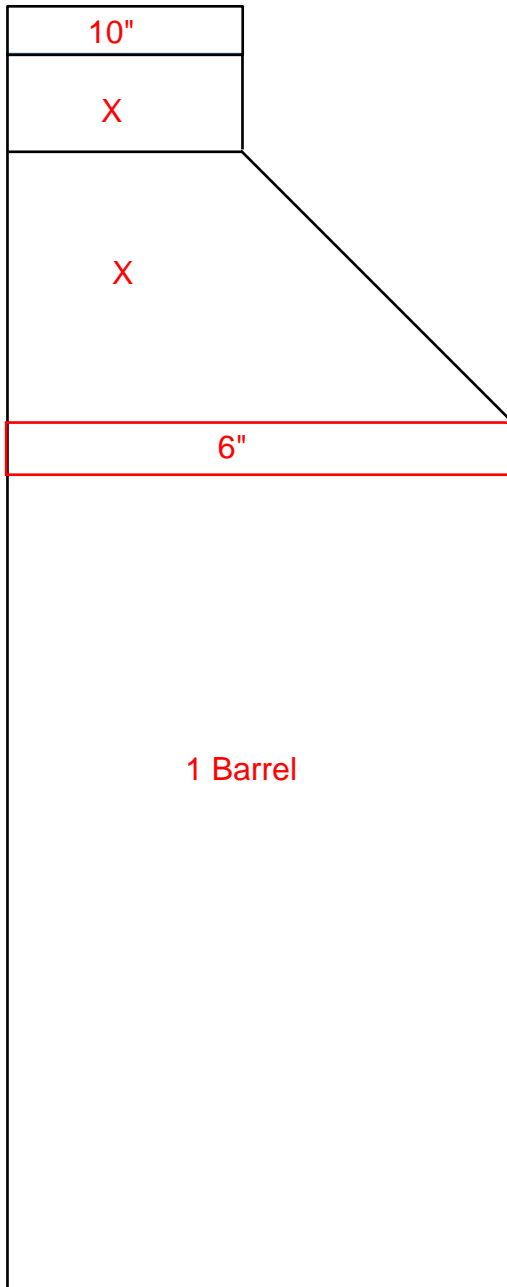
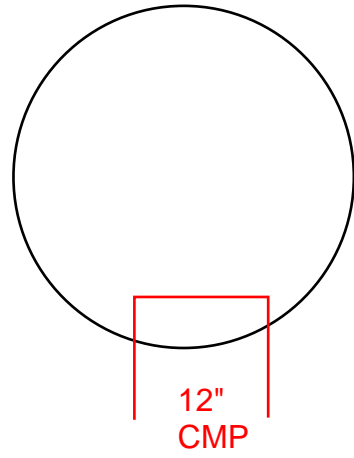
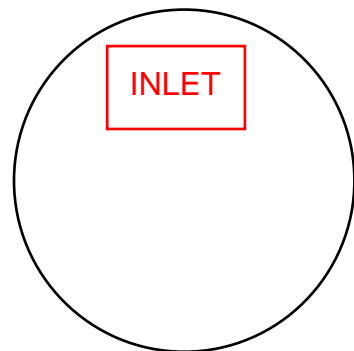
- Non-standard inlet, 11.5" x 15", rectangular, frame depth 10"
- No grade rings, frame placed on reducing slab
- Grout spalling around pipe penetration
- Metal loss at invert of pipe

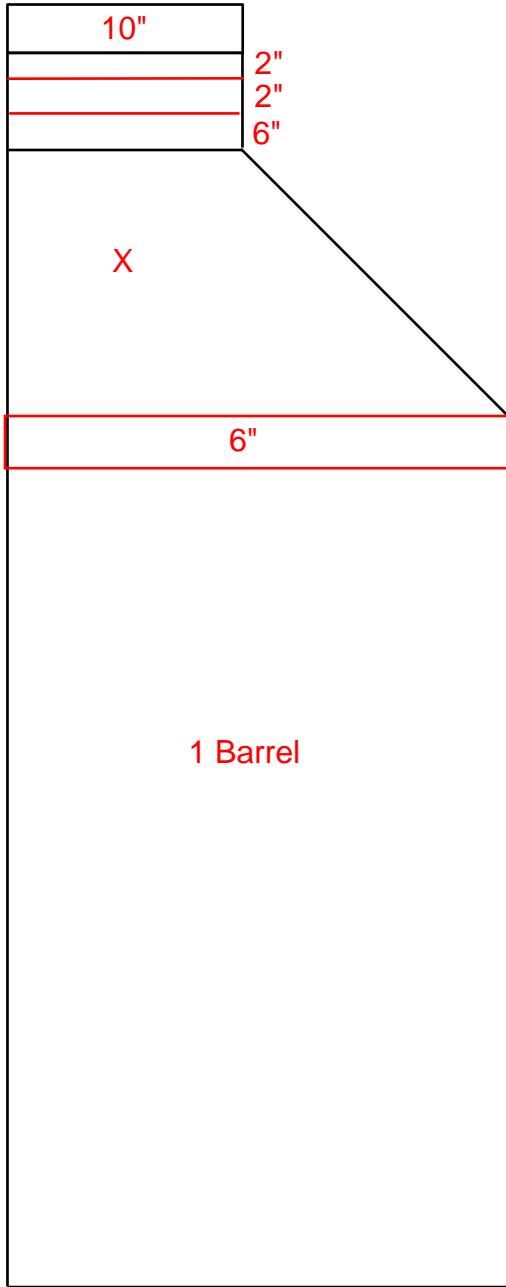
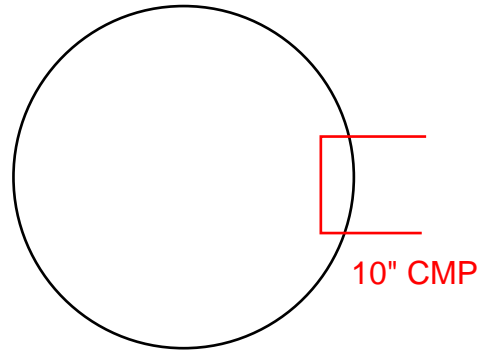
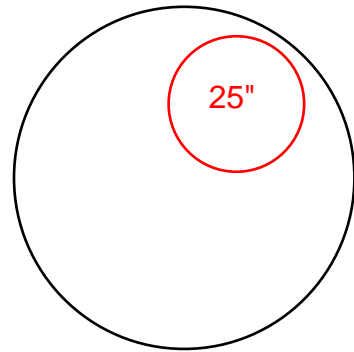
- Flat intake lid
- Minor vertical cracking in 6" grade ring
- Minor grout spalling in pipe penetration
- Significant debris in sump

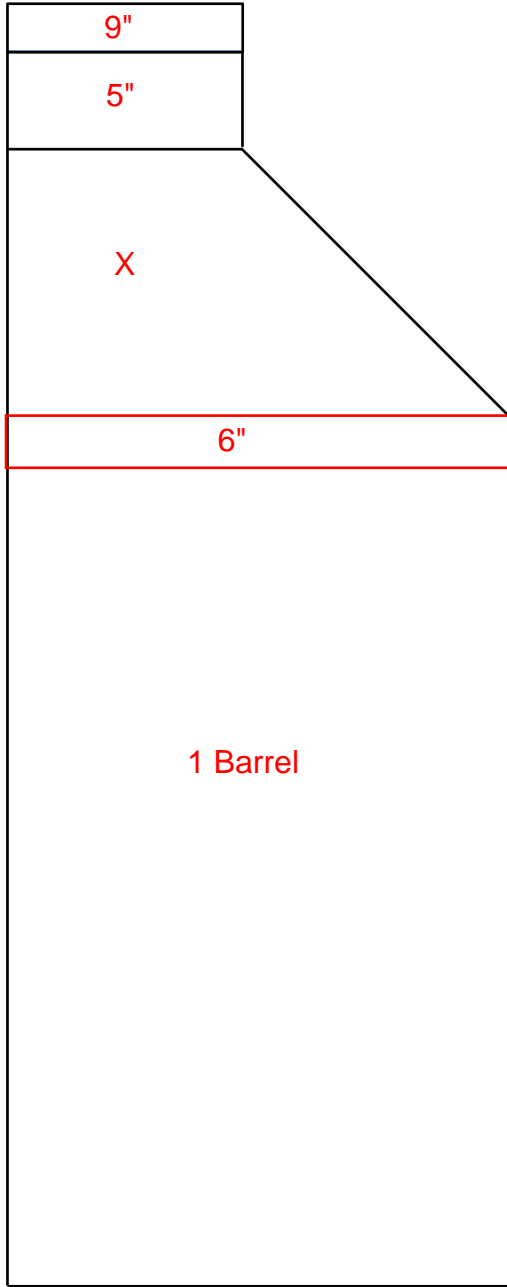
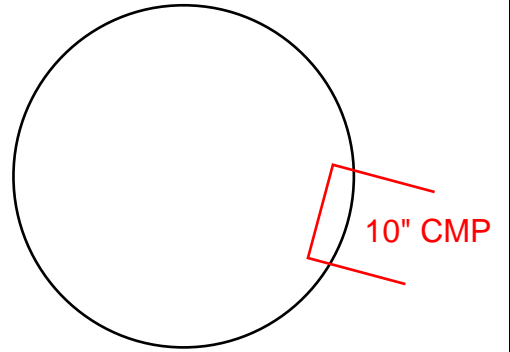
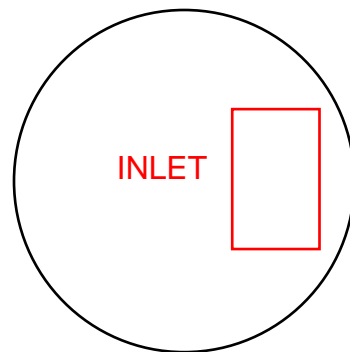
MANHOLE SKETCH

- Type 2 curb inlet, 24" x 18"
- Curb inlet is at skewed angle from curb line
- Grade ring placement is offset from frame and reducing slab
- Crack in grout above pipe penetration

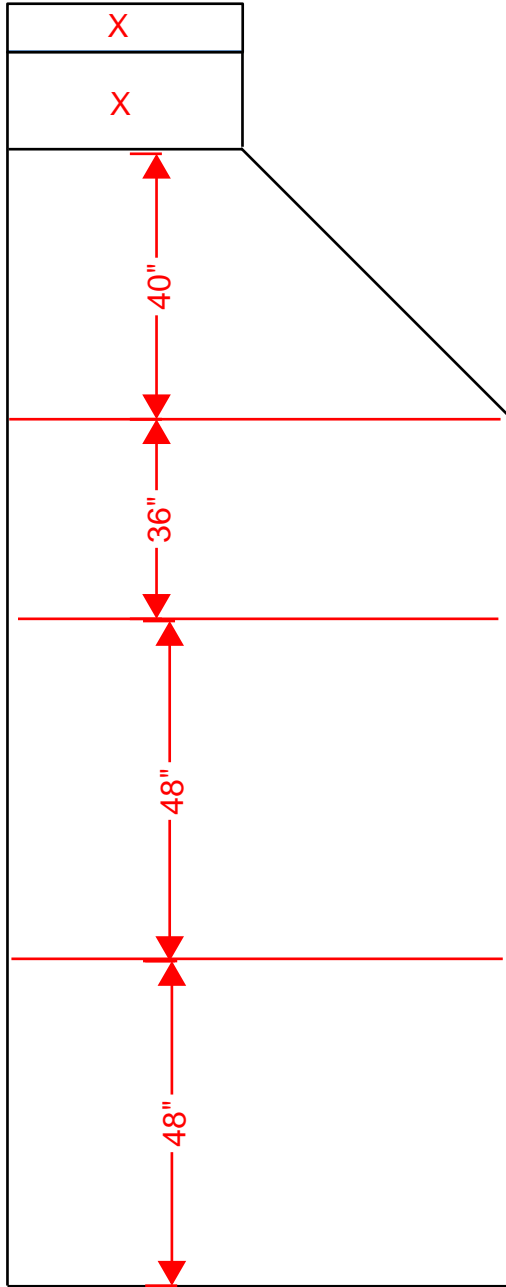
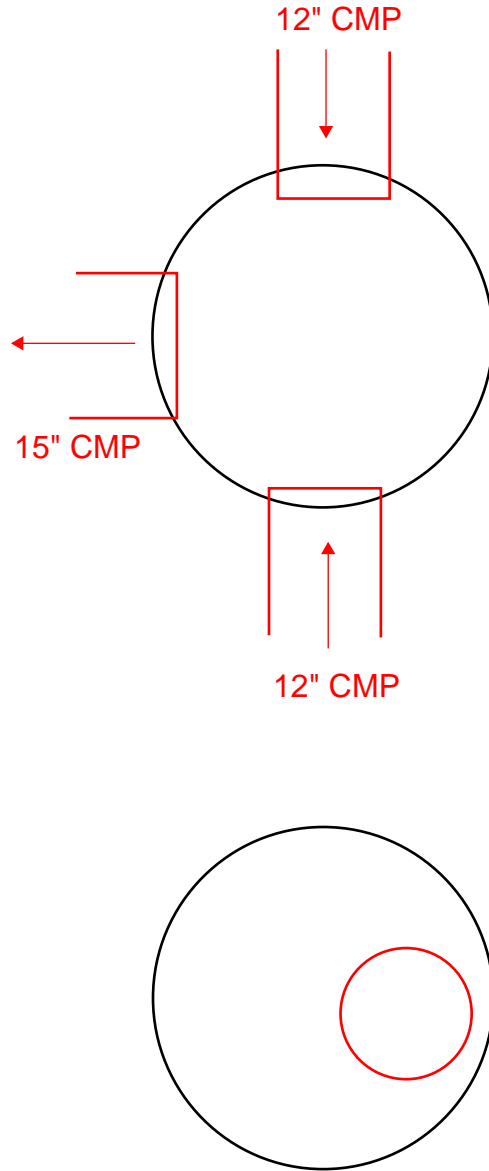
MANHOLE SKETCH

- Non-standard lid with 3 angle pieces welded onto lid
- 12 non-standard steel ladder rungs

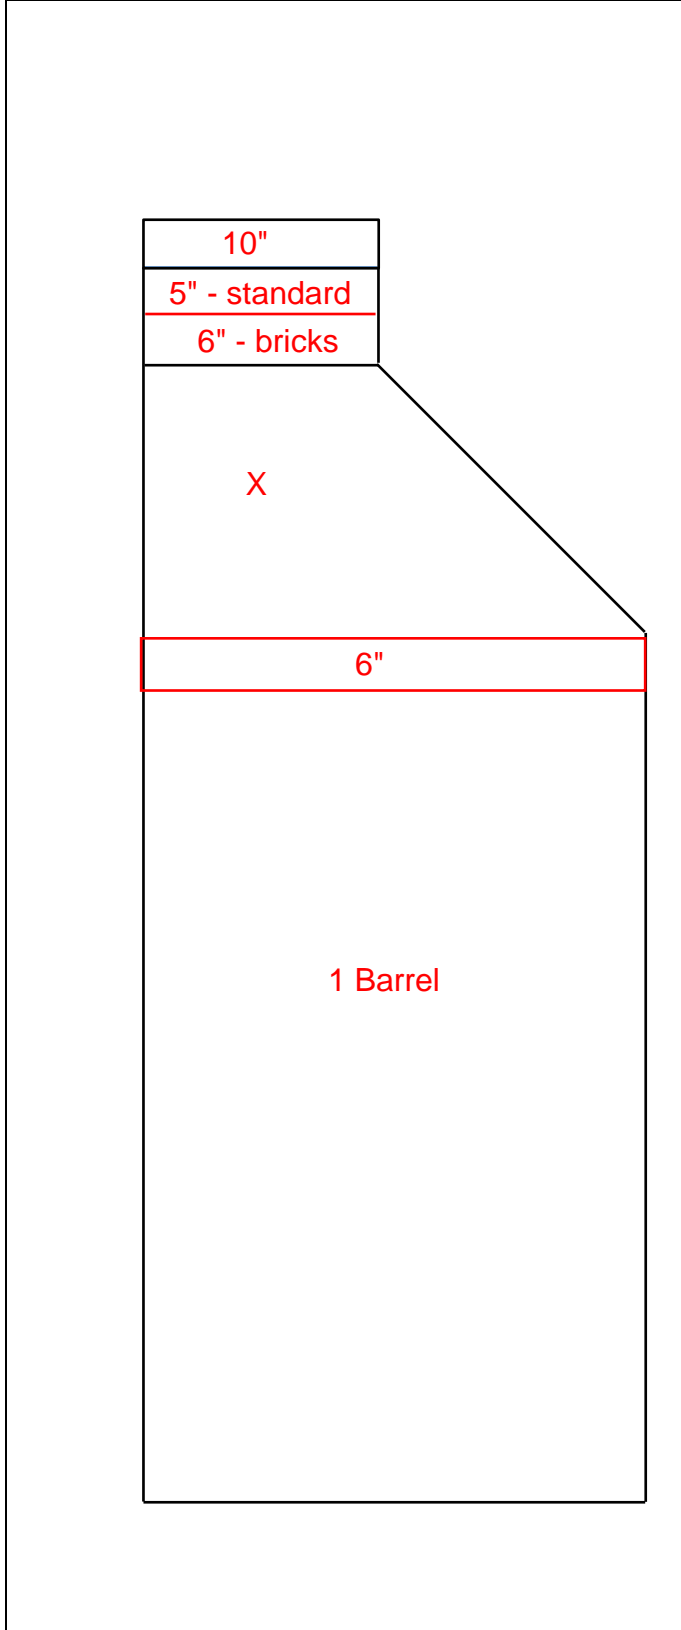
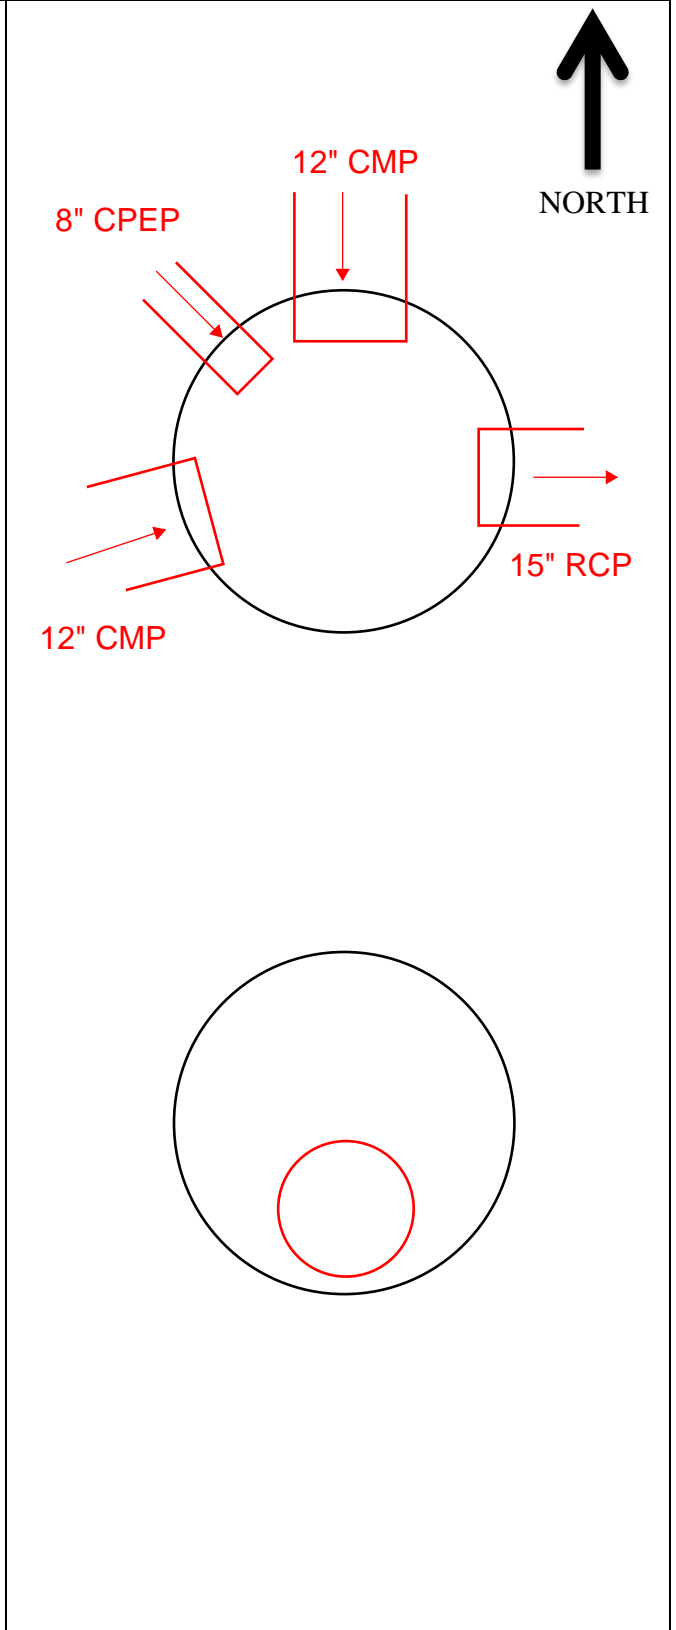
MANHOLE SKETCH

- 1 layer of non-standard grade ring is composed of bricks (in poor condition)
- No cone, grade rings on reducing slab
- 2 visible non-standard steel ladder rungs, 17" apart
- Non-standard frame with 10" height
- Non-standard lid
- Some sediment buildup in pipes
- Grout cracking at west pipe penetration
- NW pipe (8" plastic) was not shown in MOA record drawings and MOA drainage arcgis map

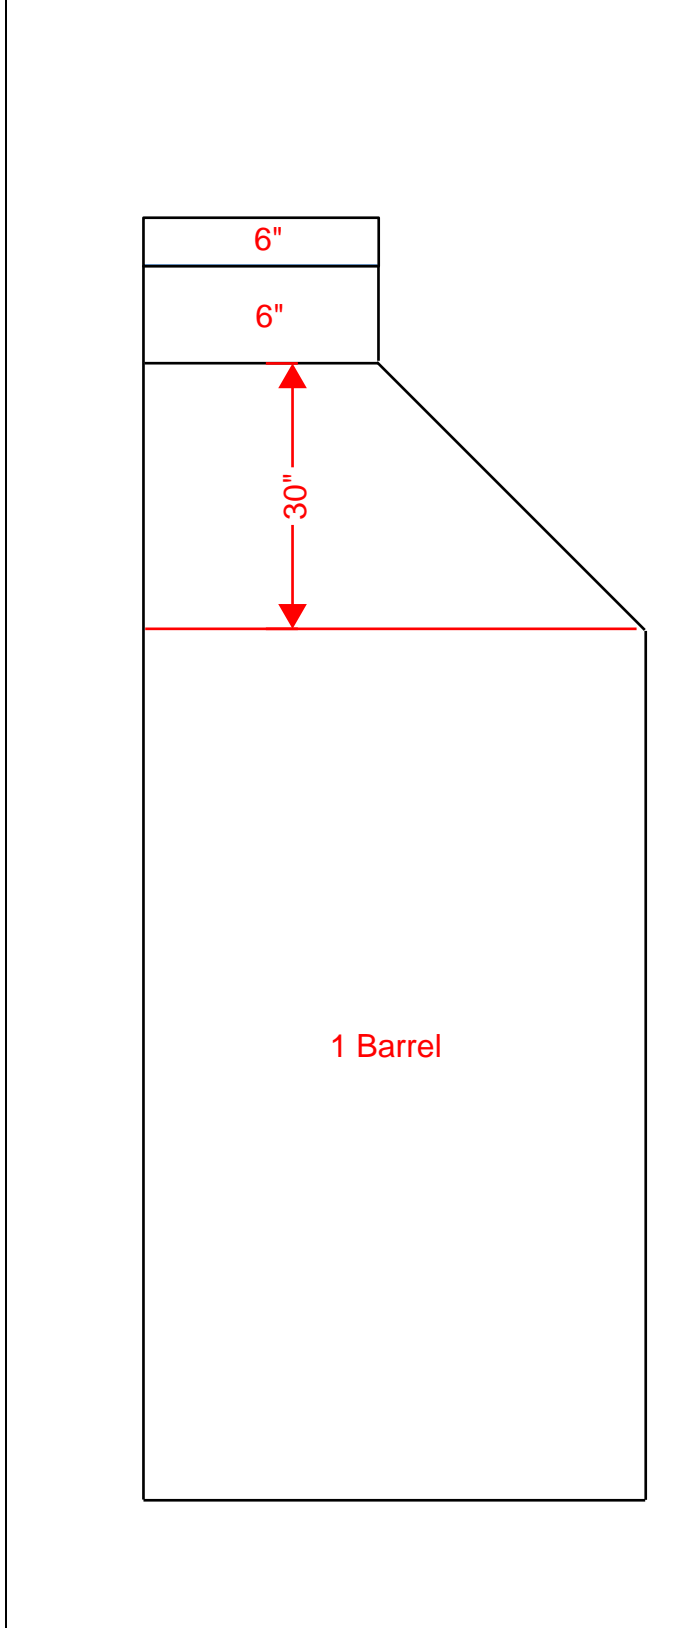
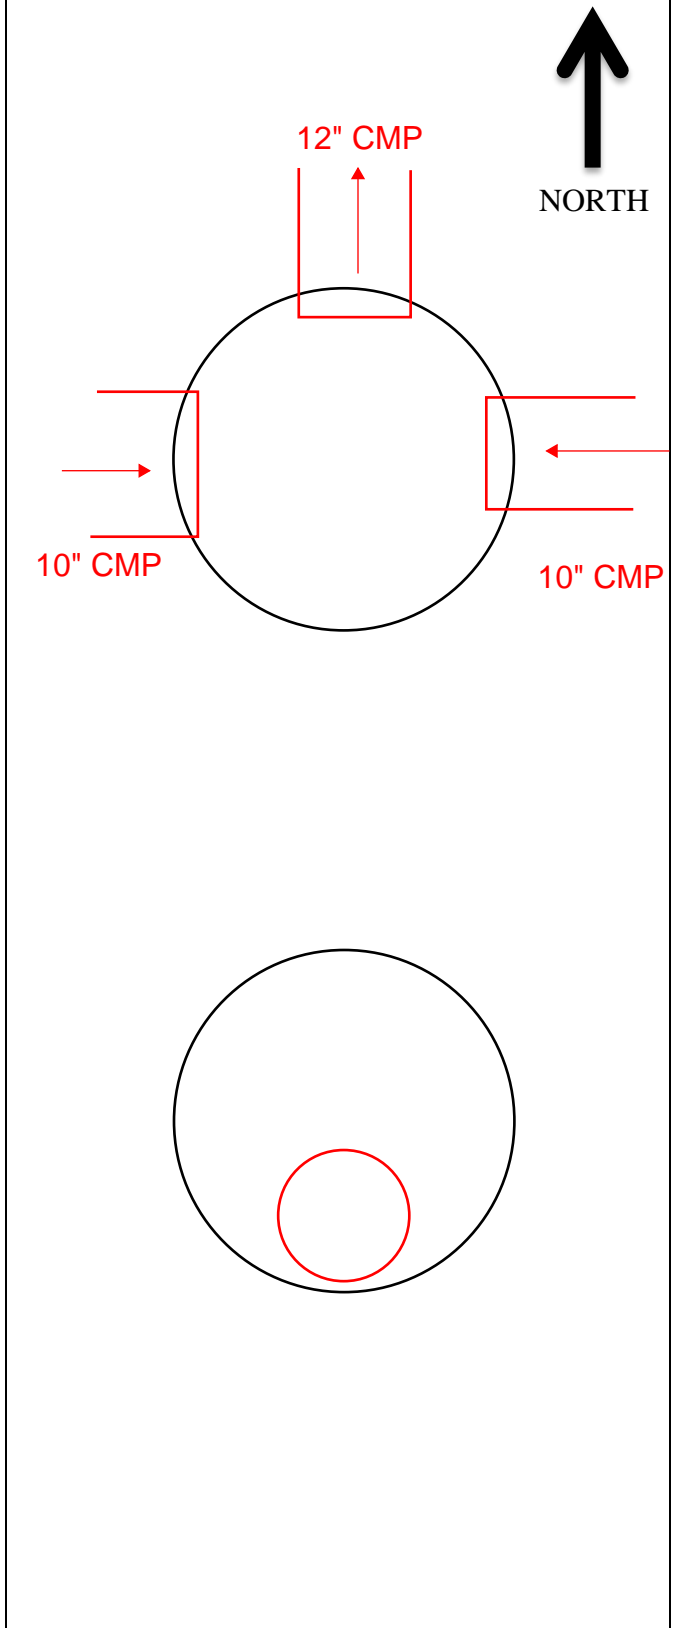
MANHOLE SKETCH

- 4 non-standard steel ladder rungs
- Buried MH cover in gravel
- Vertical cracking in grade ring
- Grade ring placement is offset from cone and frame
